Cobra AERO A33N

Operations, Maintenance and Service Manual

A33 Operations, Maintenance and Service

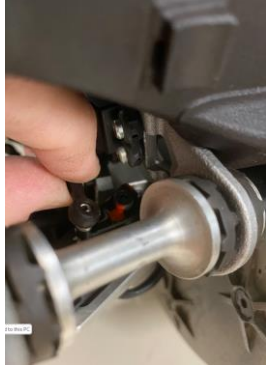
Pinch and rotate linkage to check

The servo linkages are as important as the servos themselves and as such, should be treated with the same care and scrutiny as the servos. Linkages need to pass the “Goldilocks” inspection criteria: they cannot be too loose, and they cannot be too tight. Too loose is indicated by a lash felt in the linkage when moving it manually. Grab the center of the linkage and move it along its axis, noting if any slop can be felt in the linkage assembly. Lash in a linkage leads to position hysteresis. Hysteresis in a throttle servo can result in unrepeatable engine speeds for a given throttle input. To determine if a linkage is too tight, pinch each linkage with your thumb and index finger and rotate the linkage, noting the effort it takes to move it. Another method that would indicate a linkage is too tight would be to cycle the servo and note how much the servo rocks in its soft mounts. As these are largely qualitative inspections, it is good to note how a new engine and linkage feels to establish a baseline for what is considered “OK” for both methods.

1. A too loose or easily removed linkage must be replaced with a new linkage.
2. If the linkage is too tight then remove the linkage and note any problems that may be causing the condition (dirt, FOD, etc.)
 - a. To remove a linkage, use a wide flat tool under the printed arm and gently twist the tool to pry the arm from the ball.

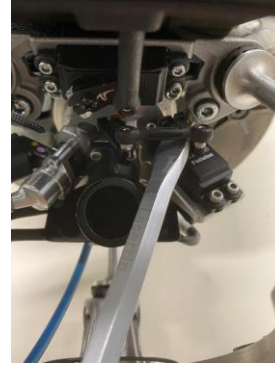
pry linkage to remove

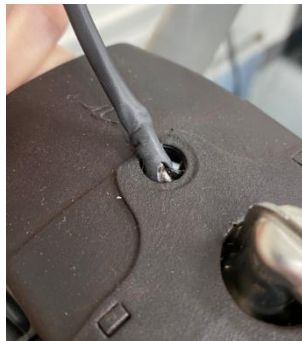
Chafing through wire protection

1. Chafing that has begun to affect the actual insulation of the wire should be considered as reason to remove the component from service until a replacement or repair is made.
2. Replace any broken or missing zip ties securing the wiring.

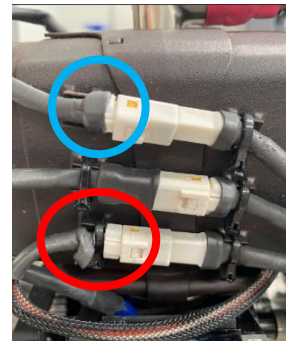
Missing and Misapplied zip tie

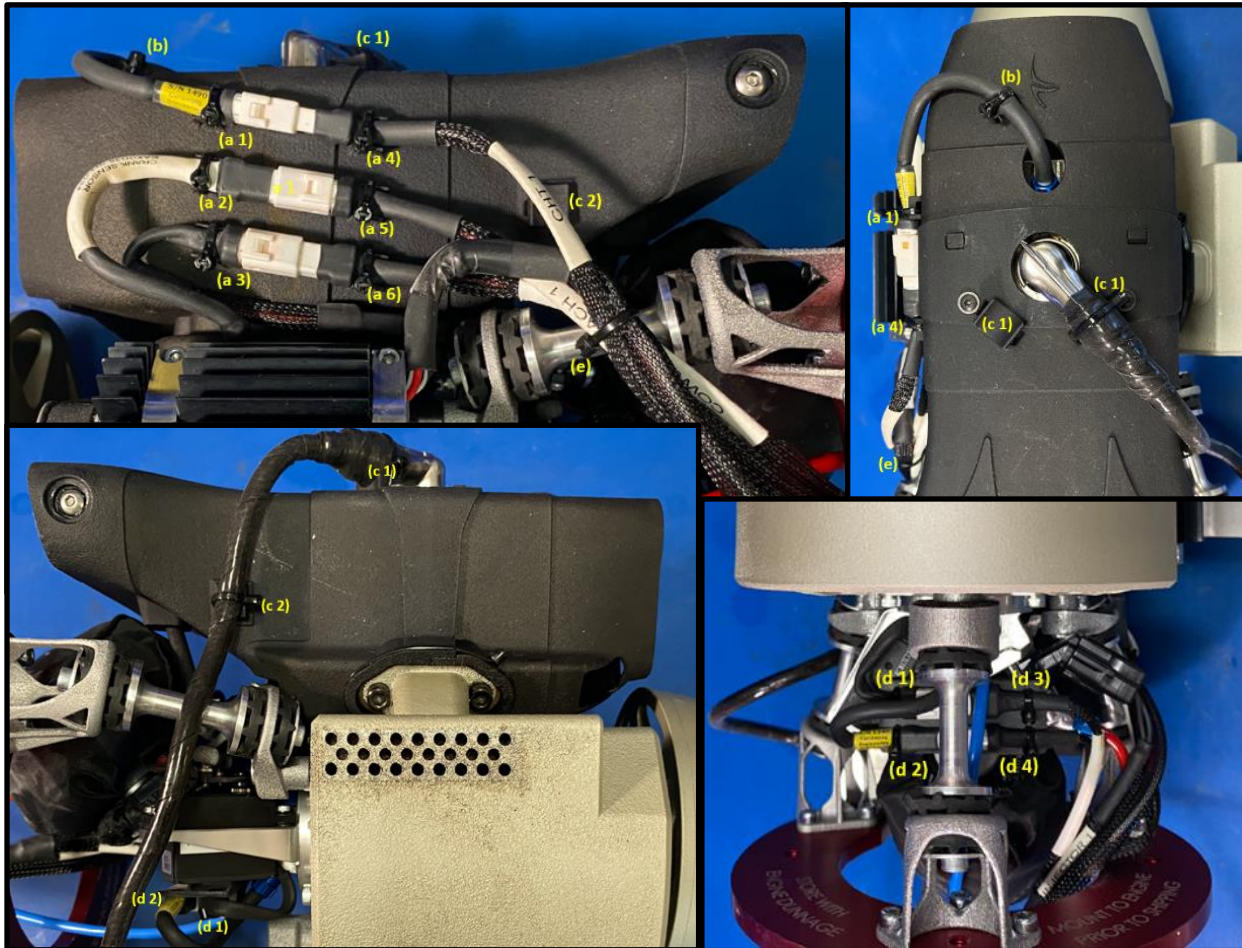
The 14 tie down locations identified specifically

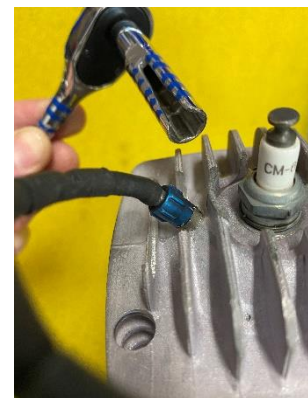
3. Use an 8mm 6-point deep socket that has been split to remove the CHT sensor.

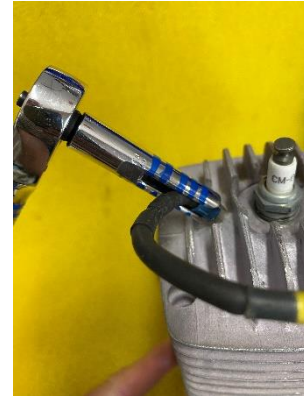
4. The 8mm split socket will fit over the blue anodized base of the sensor for removal.

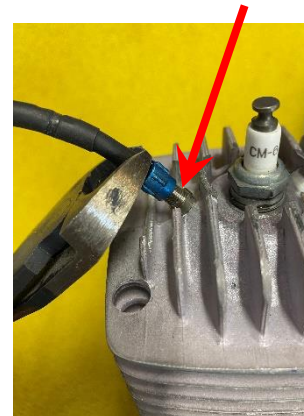
5. Occasionally, the blue anodized nut will break free from the sensor (note the exposed threads on the sensor head indicated in this picture). If this happens, the sensor will not be able to be removed without damaging the wires inside.

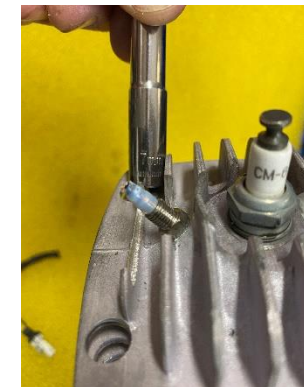
8. When installing a sensor, do not overtighten.

15 to 20 in-lbs is sufficient to hold the sensor.

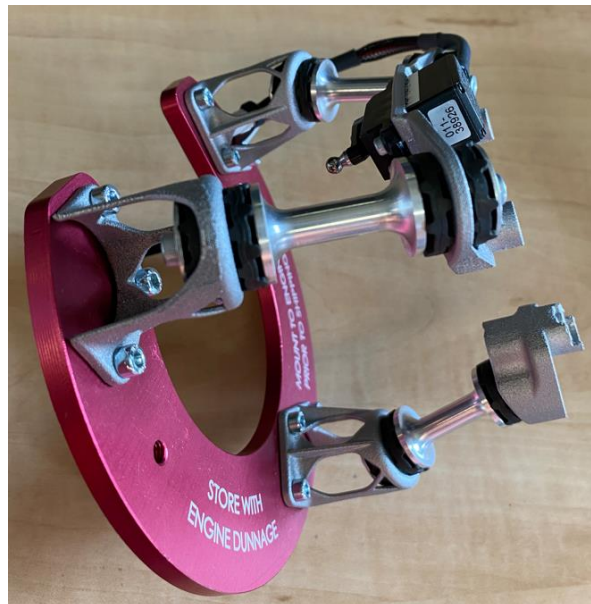
The A33 vibration mount uses 3 legs with rubber isolators on each end of the legs. The mount allows relatively free rotational movement while maintaining the thrust line of the propeller. The rubber isolators on the legs have a long service life but should be inspected regularly as though they are consumable. Rubber isolators that are missing, appear compressed or show any signs of cracking or deterioration should be replaced before flight. Also look at the washers for signs of bending or failure. A bent washer can be expected to appear over time and does not require replacement immediately. It should be noted however and replaced at earliest convenience as the washers assist in limiting the extreme ends of travel of the engine.

2. Inspect rubber isolators to identify missing, compressed or any parts showing signs of cracking or deterioration.
3. Inspect washers, noting any that are bent or compromised in any way.

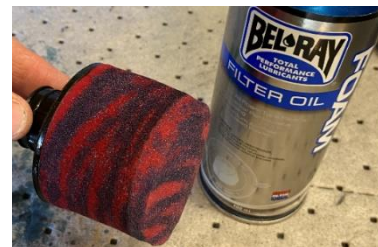
16. Spray the filter with the oil and get oil coverage on par with the following image.

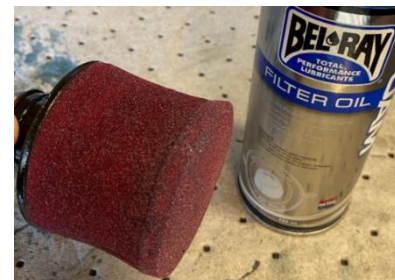
17. Use your fingers (gloved if you don't like waxy/sticky residue on your hands) to "smoosh" the foam element thoroughly and evenly distribute the oil throughout the surface of the filter. It should be an even purple color when done. Apply touch-up sprays on areas until the color is even.

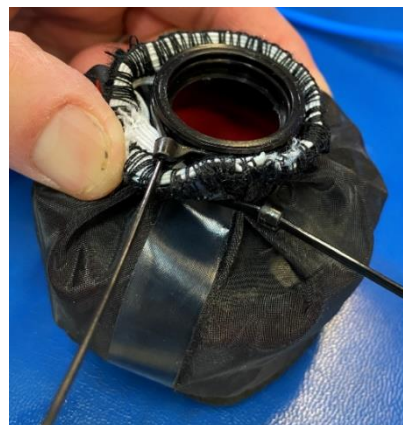
18. Reinstall the prefilter over the foam element and install two zip ties loosely over:

- a. The zip tie groove on the rubber cone of the filter element (this may still be present if not cut or removed earlier in this process)
- b. Under the elastic band on the fine mesh black sock

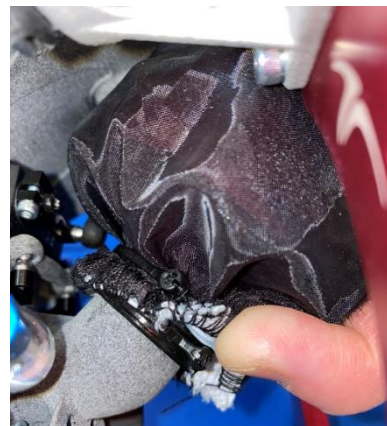
19. Put the filter element back on the intake of the throttle body. Ensure the snaps neatly into the groove on the printed throttle body inlet. Once on, tighten the zip tie holding the element to the inlet and only snug the zip tie securing the fine mesh sock to the element. Trim both.

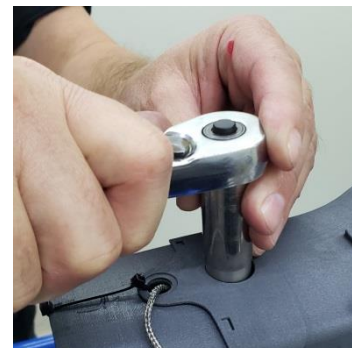
1. Snip/cut the zip tie fixing the spark plug cap to the cooling cowl.
2. Remove the spark plug cap.
3. Using the spark plug socket, loosen the spark plug.
4. Remove the spark plug by hand.

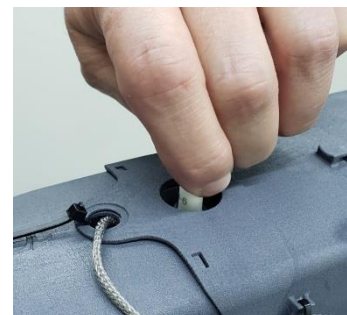
DO NOT use the Denso U20M-U as a replacement plug. This plug runs much cooler than recommended, and it is very prone to fouling.

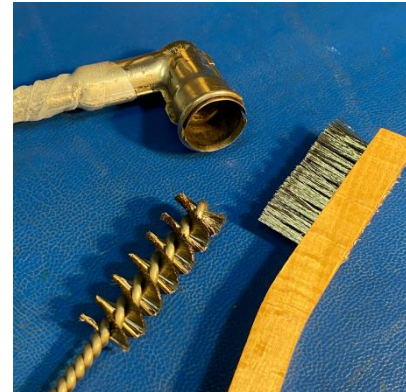
1. If some of the problems listed in the discussion are experienced, the following are recommended.
 - a. Remove the spark plug cap and note the condition inside spark plug cap. A wire brush can be used to clean the lower inside of the spark plug cap that is in contact with the hex on the spark plug.

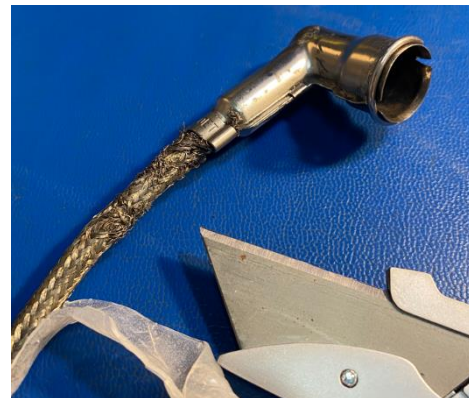
- i. In this example image, the metal braid nearest the cap is in very poor condition. This particular unit functions well however the damage is indication that the braid is being un-necessarily stressed under vibration in its current installation. The issue causing this fraying should be mitigated for the CDI to continue functioning at peak performance.

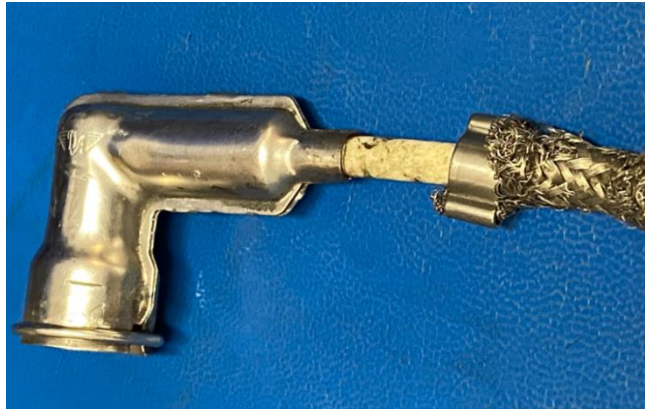
- ii. Complete breaks in the ground path to the CDI case should be reason to remove the CDI from service until corrected. In this example, the pinch clamp (oetiker clamp) no longer holds the braid to the spark plug cap.

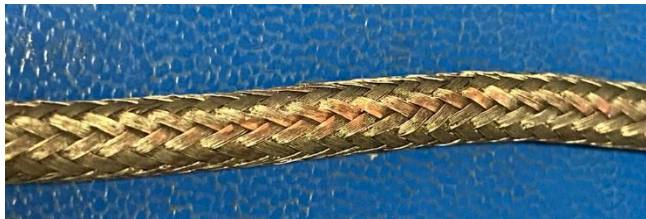
- iii. The earliest indication of an issue with chafing that may turn to braid wear and/or fraying is evidenced by the silver-colored plating being worn away from the copper braid on the high tension line.

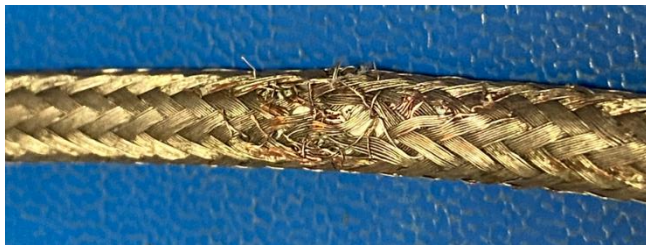
- iv. Eventually the strands in the copper braid will wear through and begin to fray

- v. If left unchecked, the fraying will continue until the ground path is broken. Re-apply self-sealing silicone tape (or similar) to the affected area will stop the fraying from propagating.
